# Fire Hydrants Along the Way

Dry Hydrant Repair  
New Windsor, Maryland

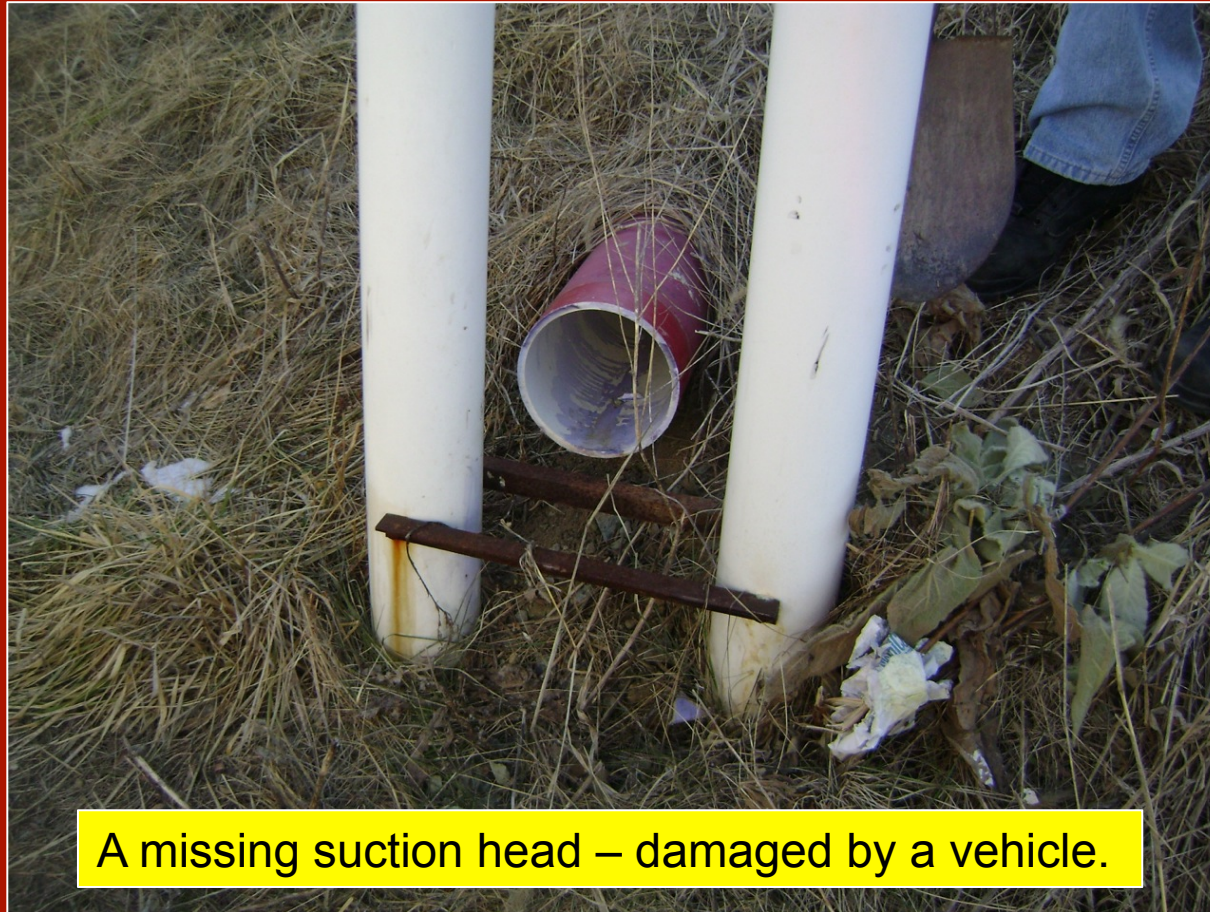
- Once again, the winter months played havoc on dry fire hydrants not protected by bollards.
- This dry fire hydrant located in New Windsor, Maryland, was a victim of some type of vehicle damage – not sure if it was a snow plow or some other vehicle.
- The dry hydrant is located at a local quarry and is a critical water supply site on that “end of town.”
- Fortunately, the damage was limited to the suction head area only. So many times, the pipe is sheared farther away from the head because of the force of a snow plow or front-end loader strike.
- Once approval and funding were made available, this repair was a quick one.

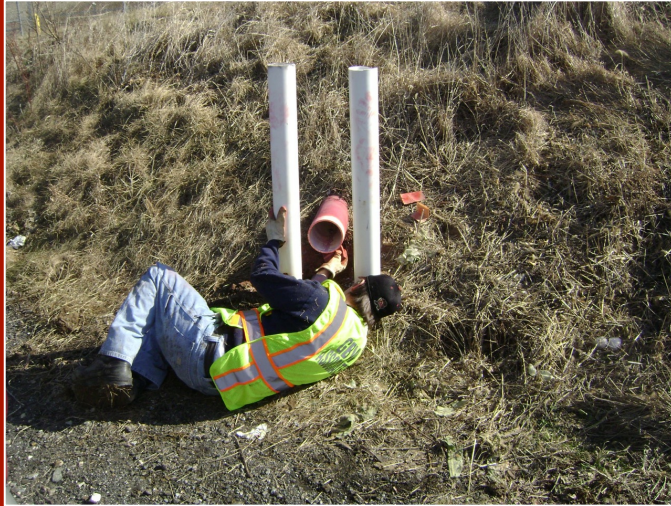
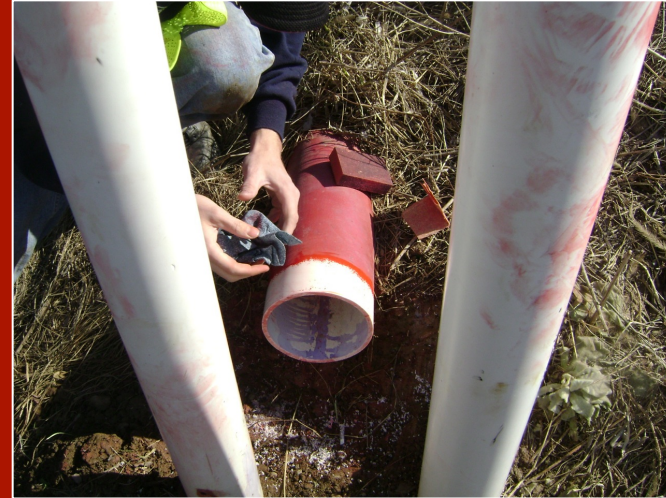
Looking at the pipe and the broken head (not shown) – it became evident that the head was glued on OVER the painted pipe. We doubt that made a tight fit – but the FD also never reported a problem using the DFH. However, the repair required the existing paint to be removed. Several solvents were tried without success and old-fashioned sand paper was used – BUT with caution so as not to reduce the diameter of the pipe. A tight fit was needed with the new coupling to ensure a good glue bond.

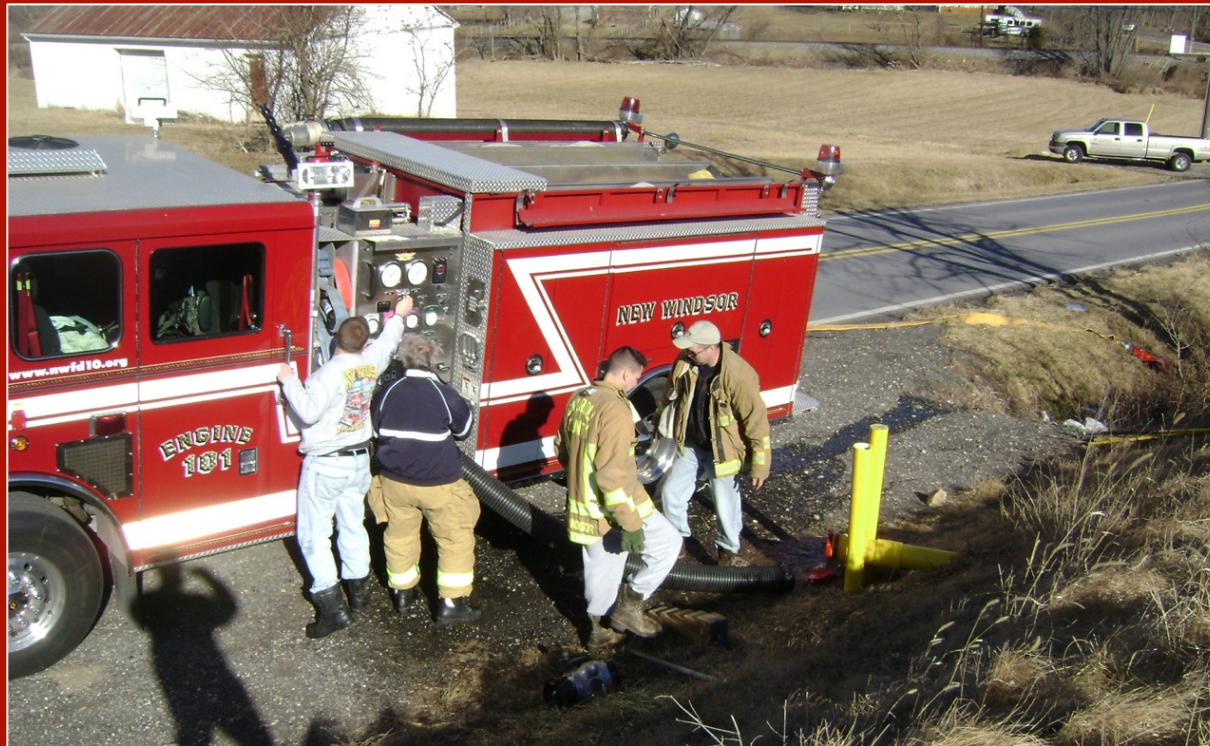
New Windsor's Engine 101 (2,000 gpm) pumper was used to flow test the repaired dry hydrant.

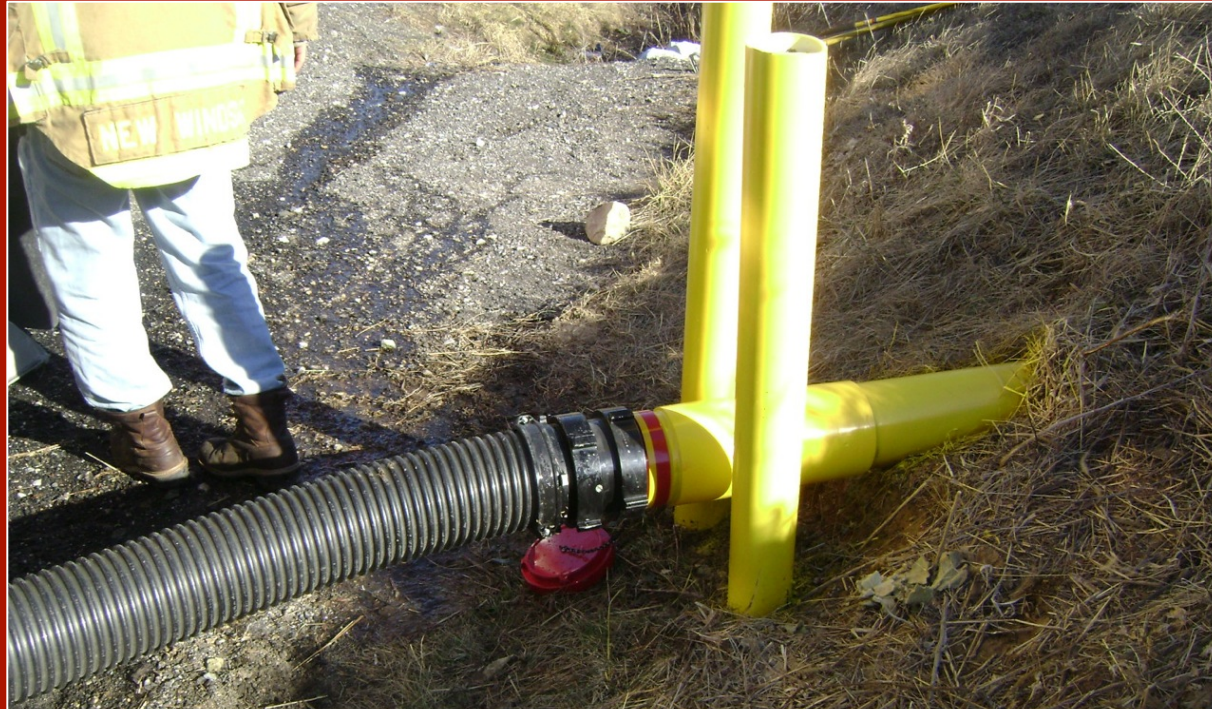
One issue when using plastic pipe is that when making connections, fittings should be just tight enough to minimize air leakage. There is no need to beat on the connection with a big hammer "just to be sure" it is tight.

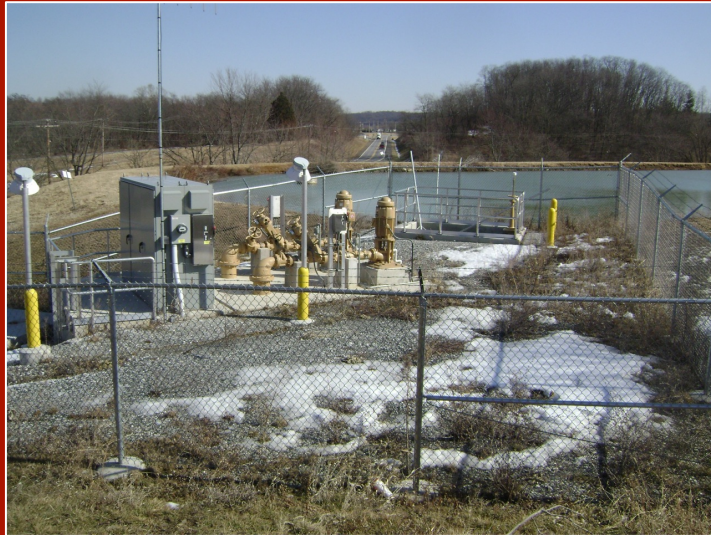
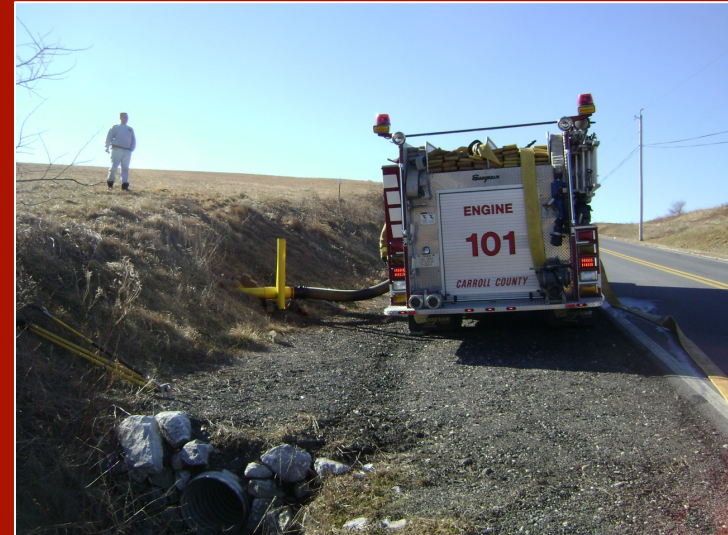
With the connections all made – the flow test was conducted. The photo on the left shows the water source – a large pond fed by outflow from a huge quarry. The best thing about the site is that lift is less than 10 feet – more like 5 feet.

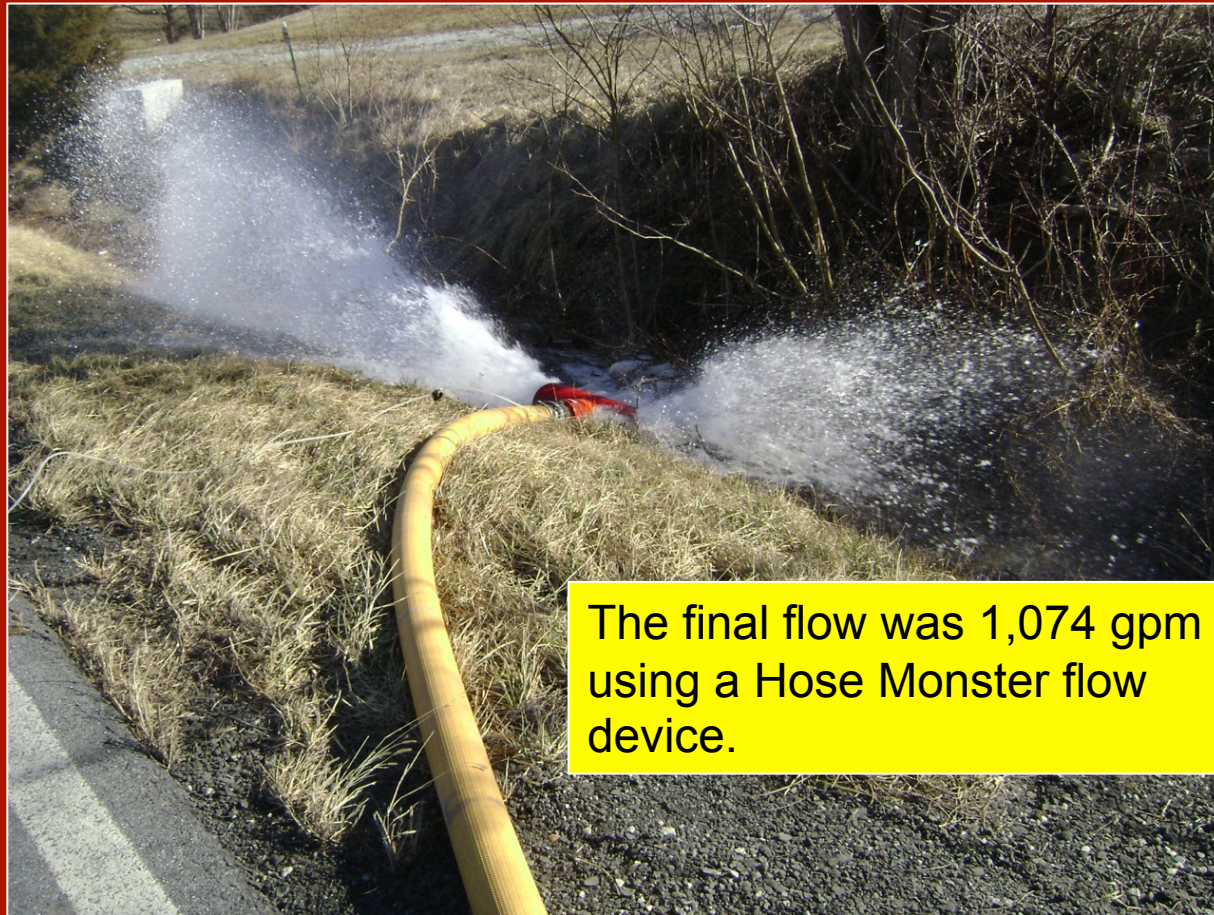
The final flow was 1,074 gpm using a Hose Monster flow device.
