Fire Hydrants Along the Way

Charleston
South Carolina
May 2011

*By Shane Darwick, Senior Associate
GBW Associates, LLC*

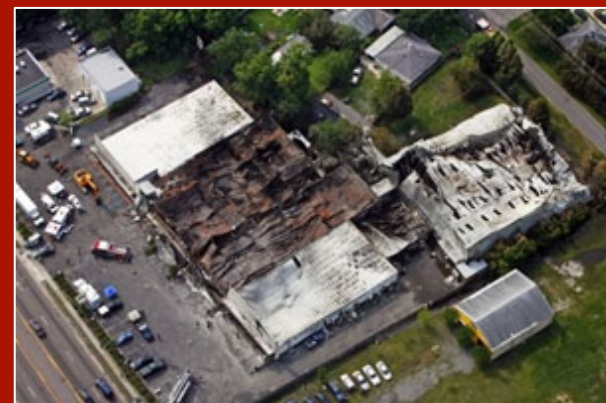
The Fire

- At the Sofa Super Store blaze, a loading dock fire spread through the building filled with highly combustible furniture. The cause was never determined, although investigators have said a carelessly discarded cigarette was the likely cause.
- The final report of the National Institute of Standards and Technology calls for national building and fire codes to require sprinklers for all new commercial retail furniture stores regardless of size, and for existing retail furniture stores with any single display area of greater than 2,000 square feet.

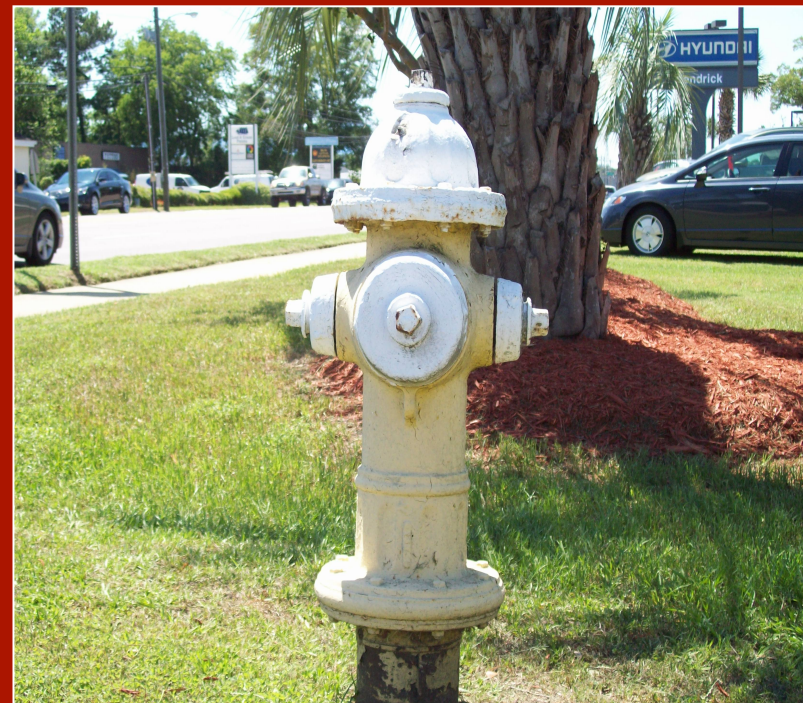
- The following facts & figures are from the **FIREFIGHTER FATALITY INVESTIGATIVE REPORT**, Sofa Super Store, 1807 Savannah Highway, Charleston, South Carolina, June 18, 2007, City of Charleston, Post Incident Assessment and Review Team Phase II Report.
- The report states water supply issues played a very significant role at the Sofa Super Store fire and contributed to the loss of the nine firefighters.

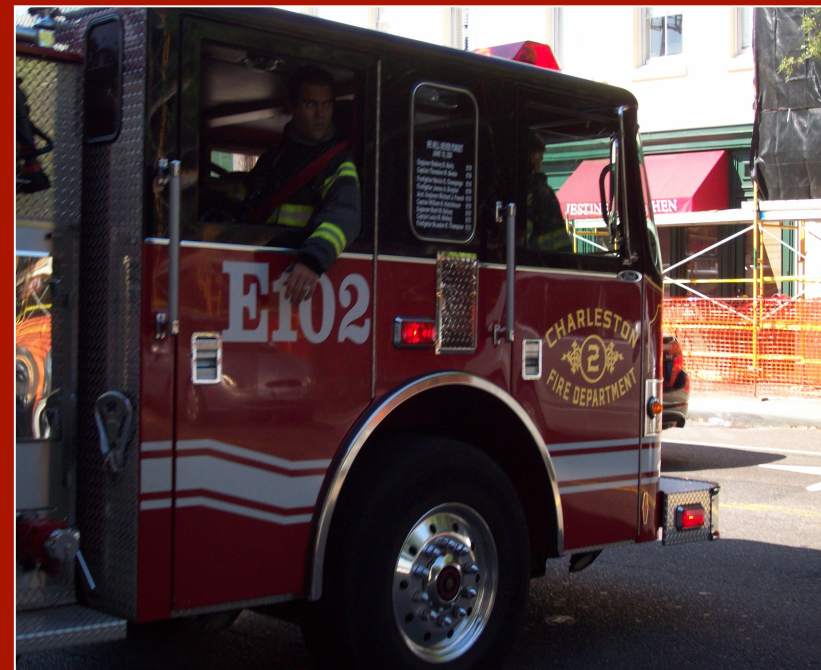
Post Incident Findings

The established practice in the Charleston Fire Department called for the first arriving engine company at a structure fire to position close to the fire scene and begin the attack using water from the on-board tank. The second arriving engine company would prepare to lay a supply line from the attack engine to a hydrant. In many cases the second engine would back into position near the first engine and stand-by to lay a supply line, if needed.

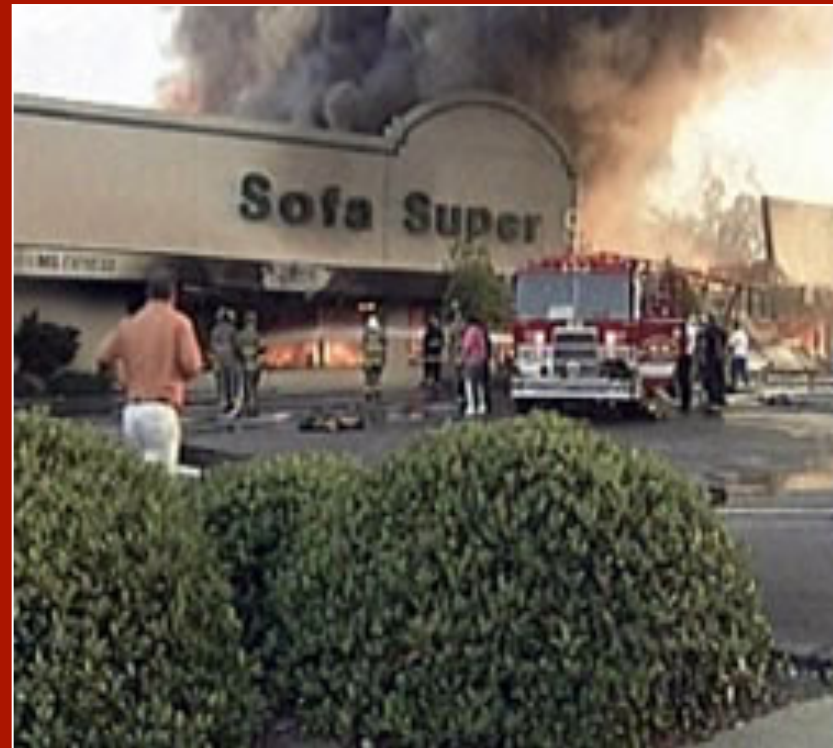
Post Incident Findings

- The Charleston Fire Department did not use large diameter hose for supply lines; the standard hose load on engine companies provided only a single bed of 2-1/2 inch hose that could be used as a supply line. This arrangement severely limited the volume of water that was available for fire attack.

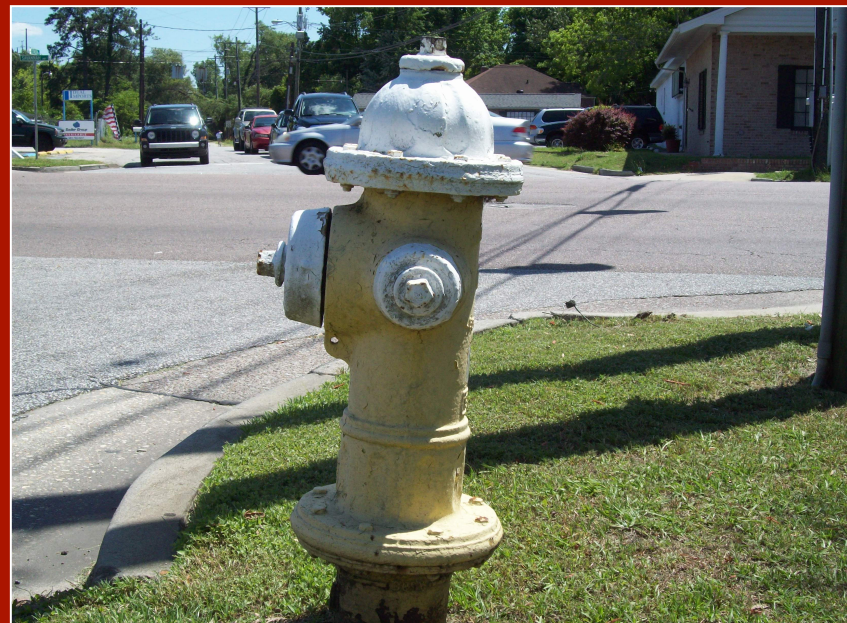
Post Incident Findings

- Senior officers attempted to compensate for the inadequate supply lines by repeatedly calling for “more pressure” from the pumpers that were connected to hydrants. The preoccupation with water supply problems distracted the command officers from effectively managing the overall incident.
- Friction loss calculations demonstrate that the 2-1/2 inch supply lines were incapable of delivering the desired flows and the problem could only be solved by stretching additional supply lines – preferably using large diameter hose.

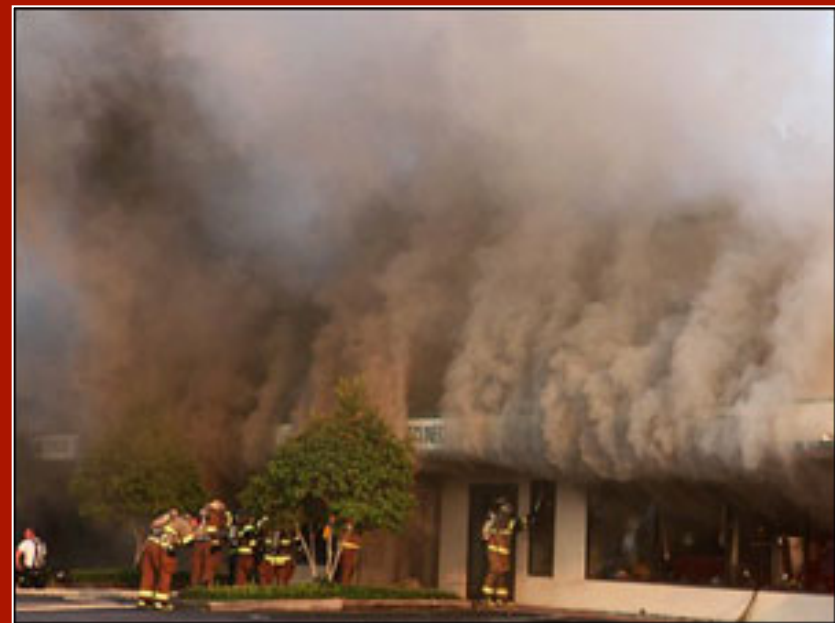
Post Incident Findings

- During later stages of the incident, several master streams were set-up and the resulting demand exceeded the volume available from the water mains and hydrants in the West Ashley area.
- The hydrants were capable of supplying all of the attack lines that were deployed during the first 30 minutes, if appropriate supply lines had been established.

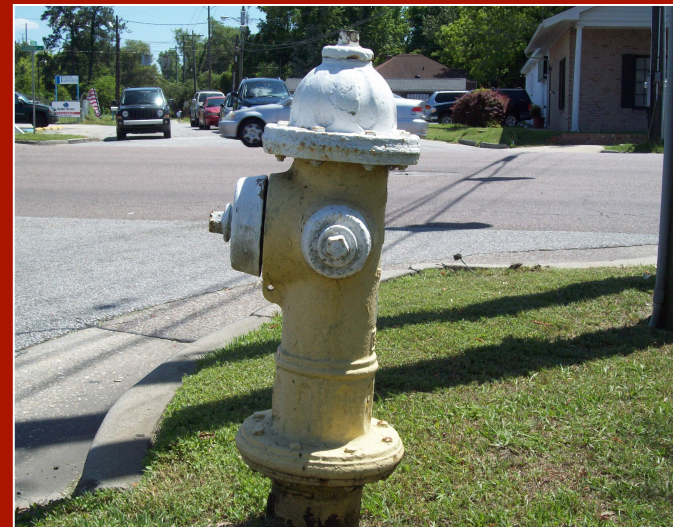
Post Incident Findings

- Most of the water problems were related to inadequate supply lines and inexperienced pump operators. The single, 2-1/2 inch supply lines that were used by the Charleston Fire Department could not deliver the flows that were required to conduct an effective fire attack, even if fire hydrants had been closer to the scene.
- The hydrant in the photo was one of the closest to the front of the building and is about 1500-feet from the scene, which is across busy Savannah Highway.

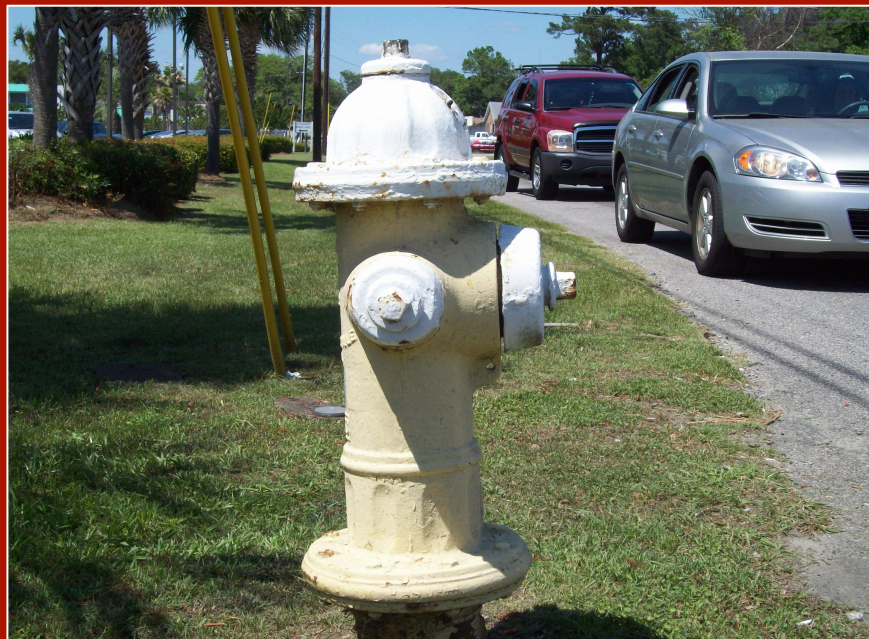
Post Incident Findings

- The engineers who were operating Engines 10 and 11 both stated that their supply lines were pulsating and attributed this condition to cars driving over the lines. Witnesses suggested that both pumps were cavitating due to inadequate flows in their supply lines.
