# Fire Hydrants Along the Way

Dry Hydrant Repair  
New Windsor, Maryland

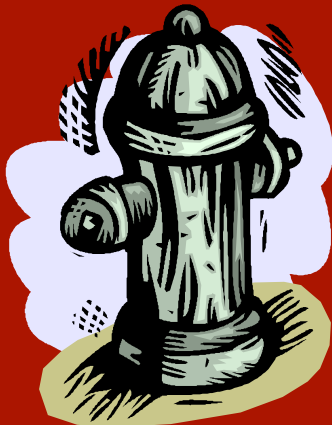
- Once again, the winter months played havoc on dry fire hydrants not protected by bollards.
- This dry fire hydrant located in New Windsor, Maryland, was a victim of some type of vehicle damage – not sure if it was a snow plow or some other vehicle.
- The dry hydrant is located at a local quarry and is a critical water supply site on that “end of town.”
- Fortunately, the damage was limited to the suction head area only. So many times, the pipe is sheared farther away from the head because of the force of a snow plow or front-end loader strike.
- Once approval and funding were made available, this repair was a quick one.
